Subject: Department of Natural Resources Washington Geological Survey,
School Seismic Safety Assessment Project, Contract No. AE 410 -
Seismic Evaluation for **Pateros School District**

School Buildings Evaluated in the Pateros School District

1. Pateros K-12 School, Main Building
2. Pateros K-12 School, Metal Shop
3. Pateros K-12 School, Music Building
4. Pateros K-12 School, Wood Shop

Pateros, Pateros K-12 School, Main Building

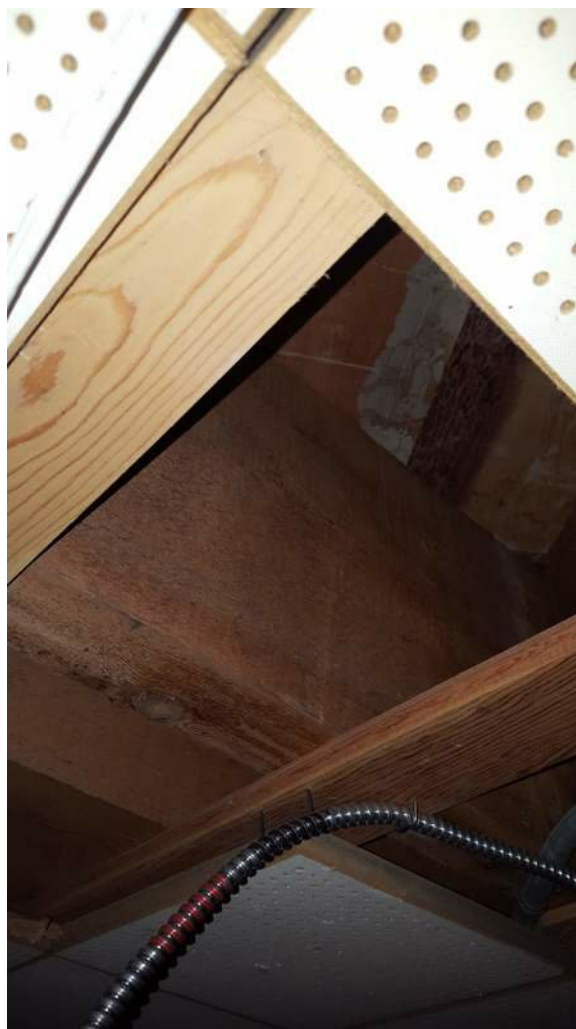
Figure 1-1. Second floor framing with diagonal sheathing visible.

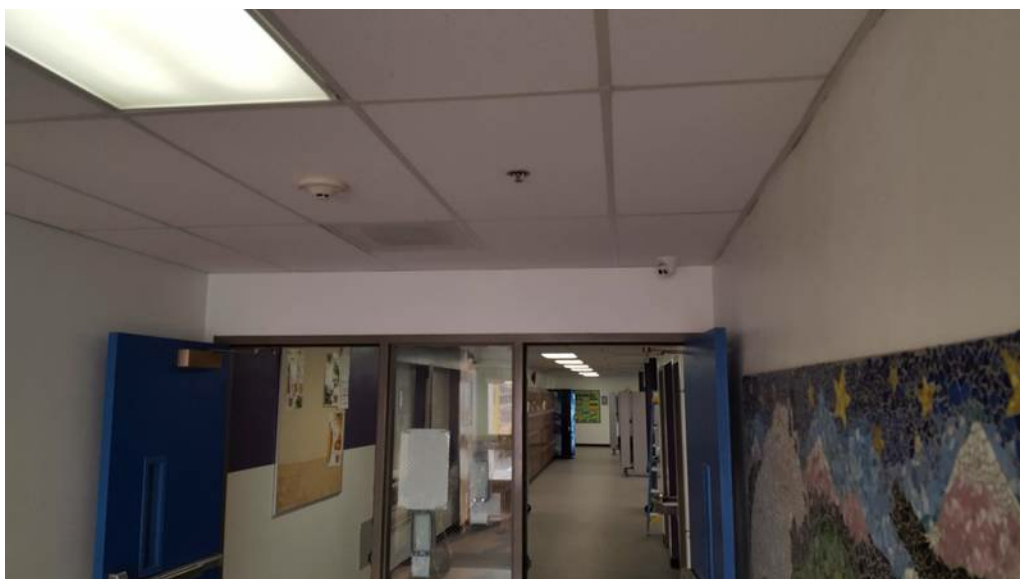
Figure 1-2. Corridor.

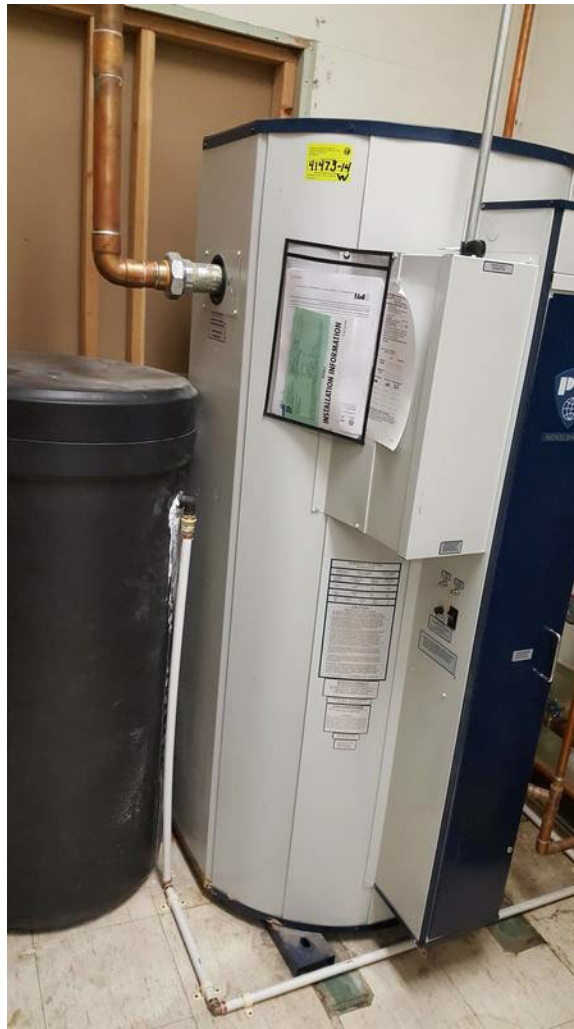
Figure 1-3. Large water heater with no visible seismic restraint.

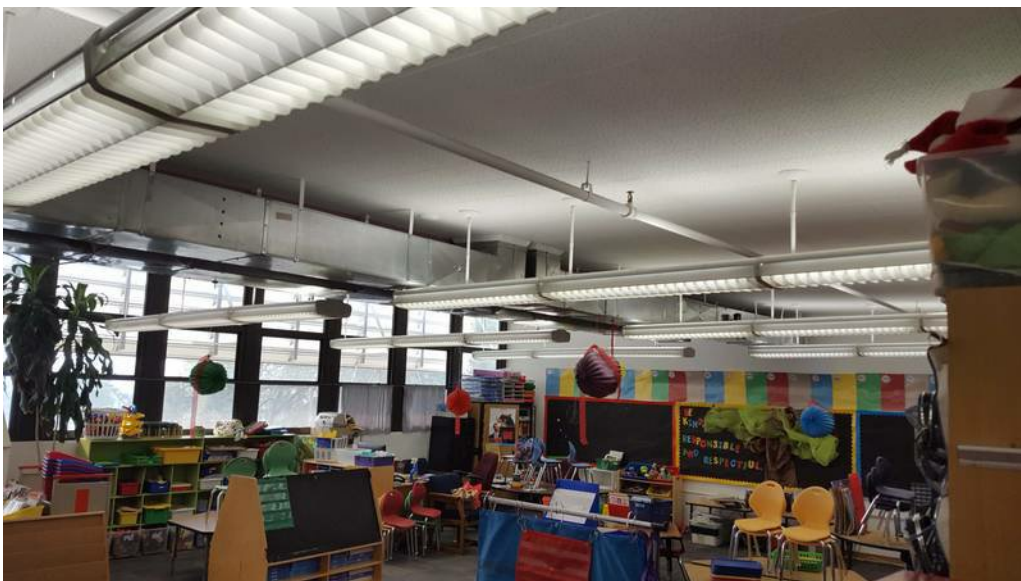
Figure 1-4. Classroom with suspended HVAC, fire suppression and pendant fluorescent lighting.

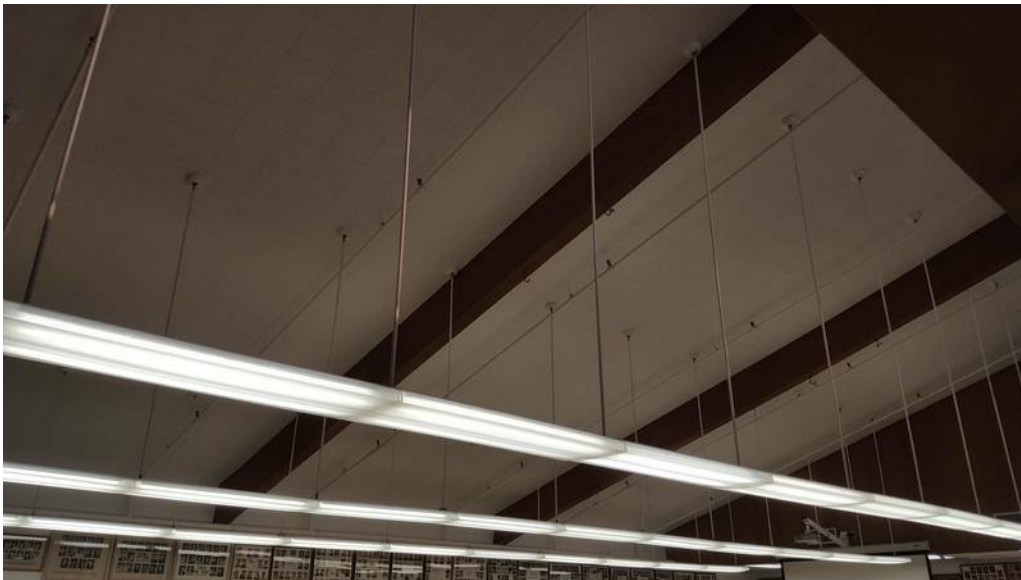
Figure 1-5. Glulam beams visible at ceiling.

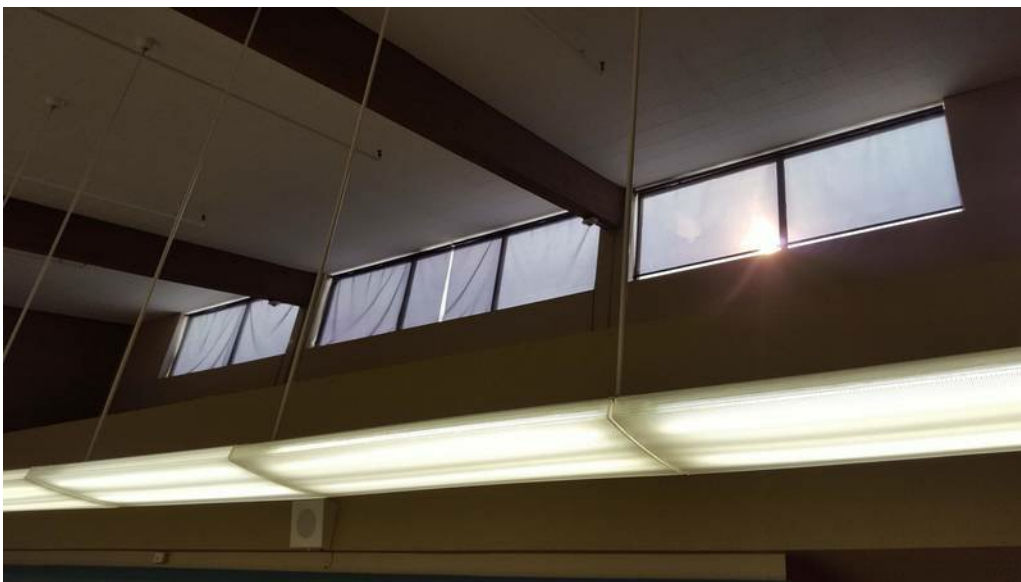
Figure 1-6. Clerestory windows with glulam beams framing into columns/wall.

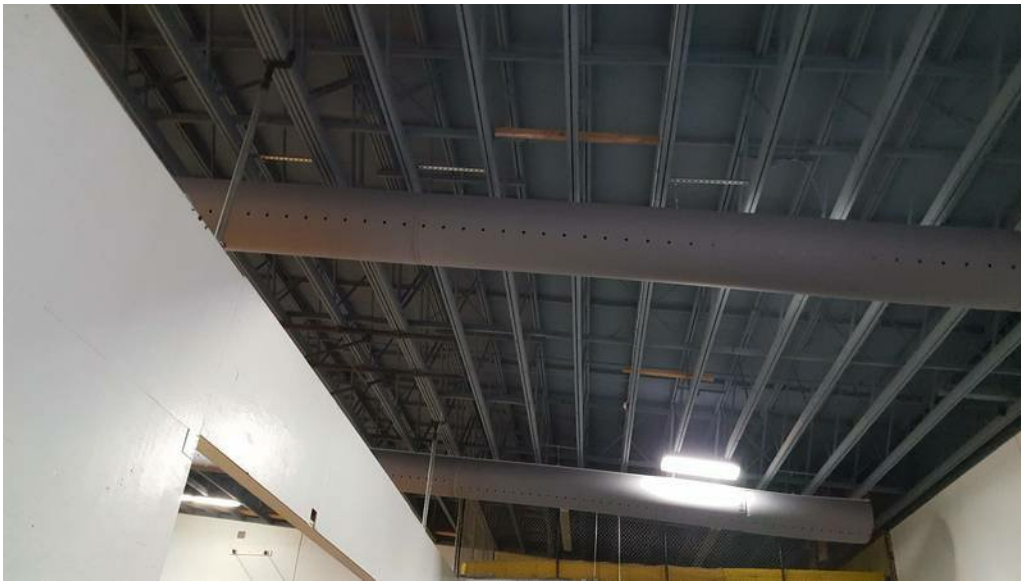
Figure 1-7. Open web steel joists at gymnasium.

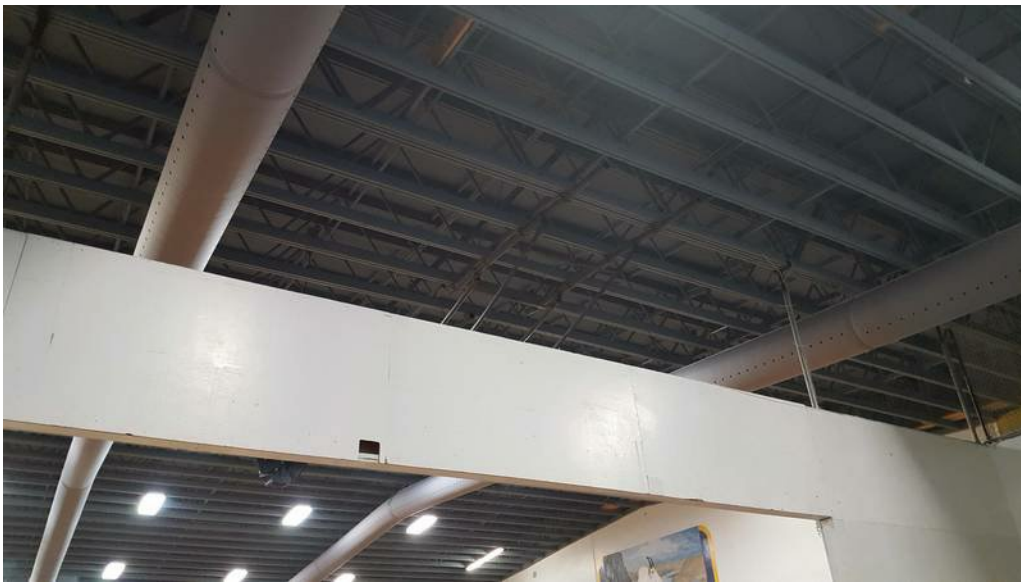
Figure 1-8. Stick-framed partition at entrance to gym.

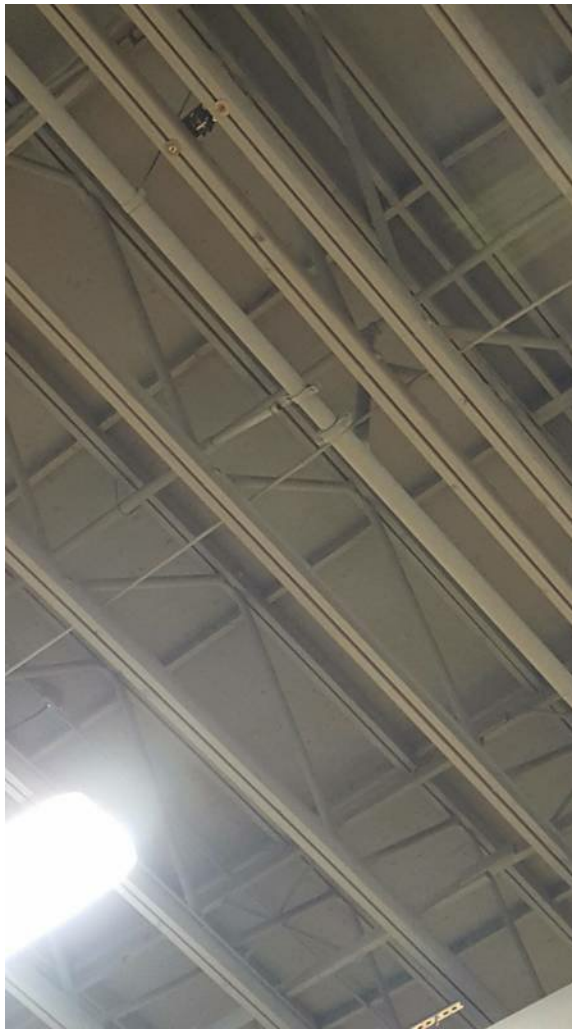
Figure 1-9. Piping with lateral bracing at gym ceiling.

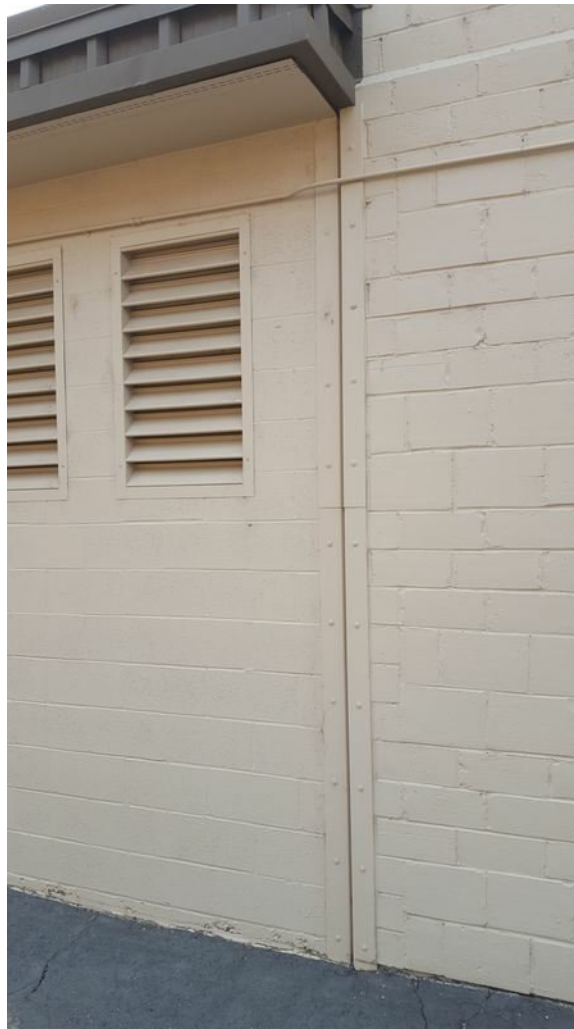
Figure 1-10. Construction joint in exterior wall at locker rooms; building appears to transition from CMU to clay block.

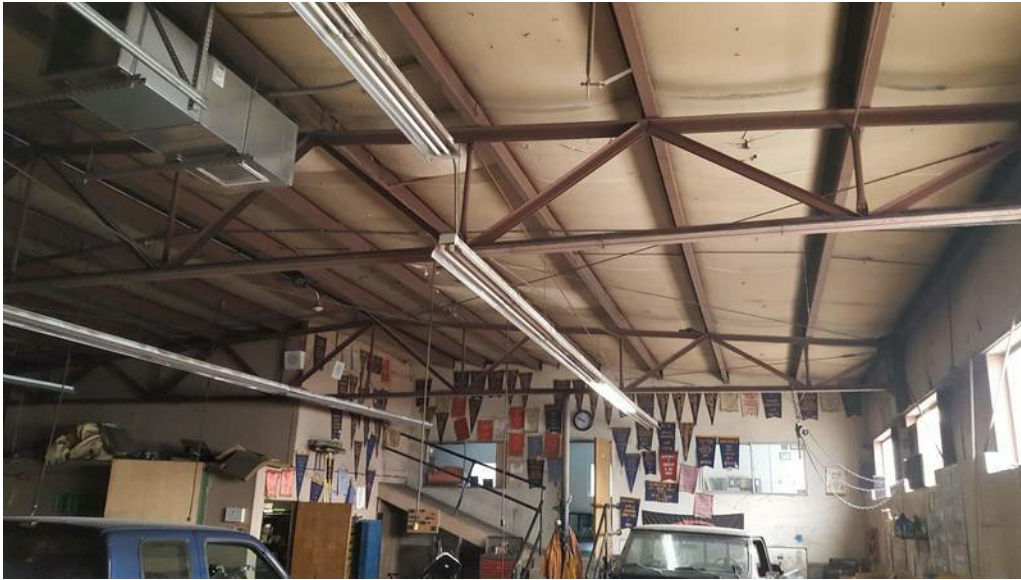
Figure 1-1. Open web steel girders with steel purlins between girders.

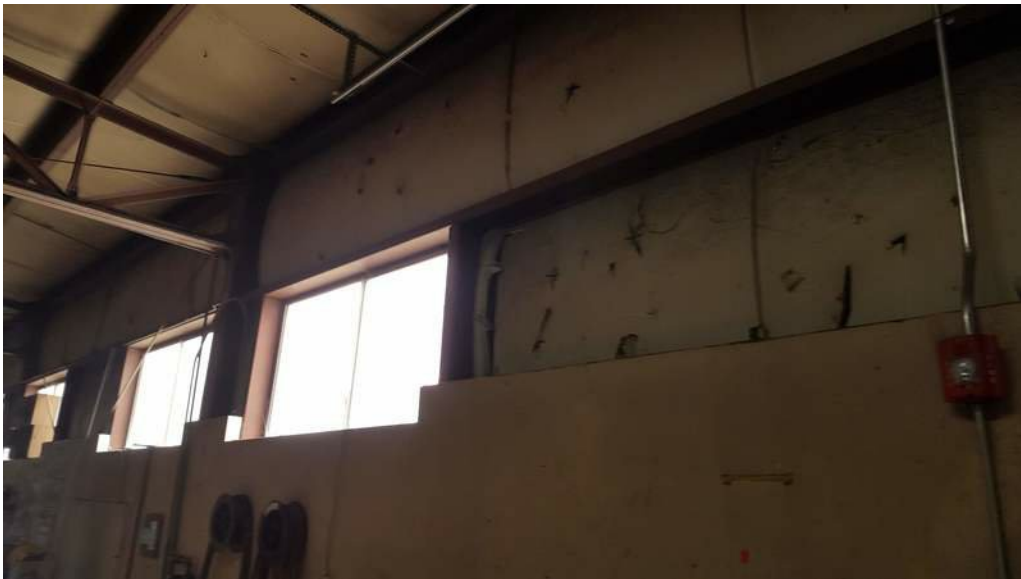
Figure 1-2. Interior view of exterior wall showing wind girts between columns.

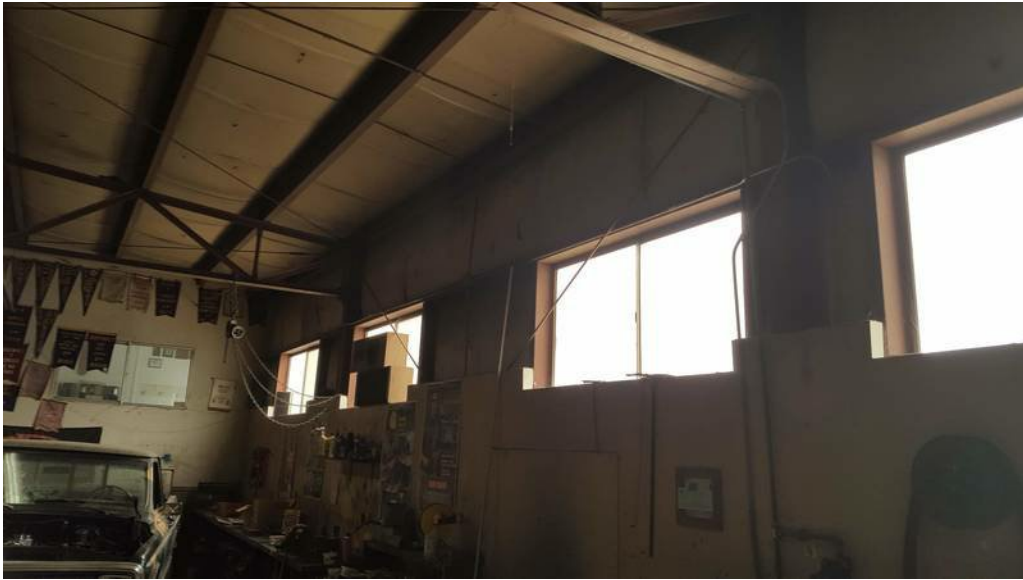
Figure 1-3. Additional view of exterior wall.

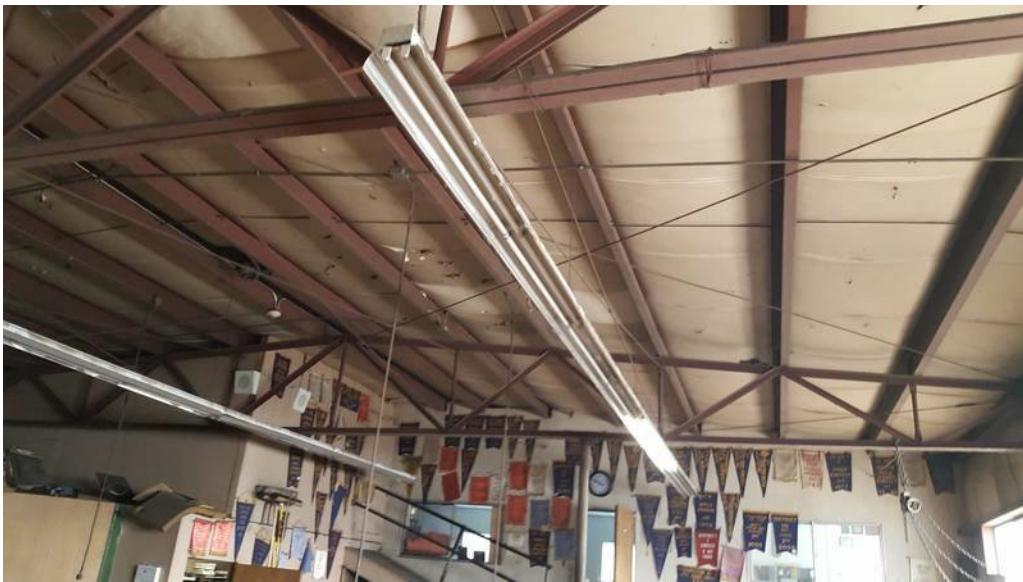
Figure 1-4. Ramp to storage area/upper level visible.

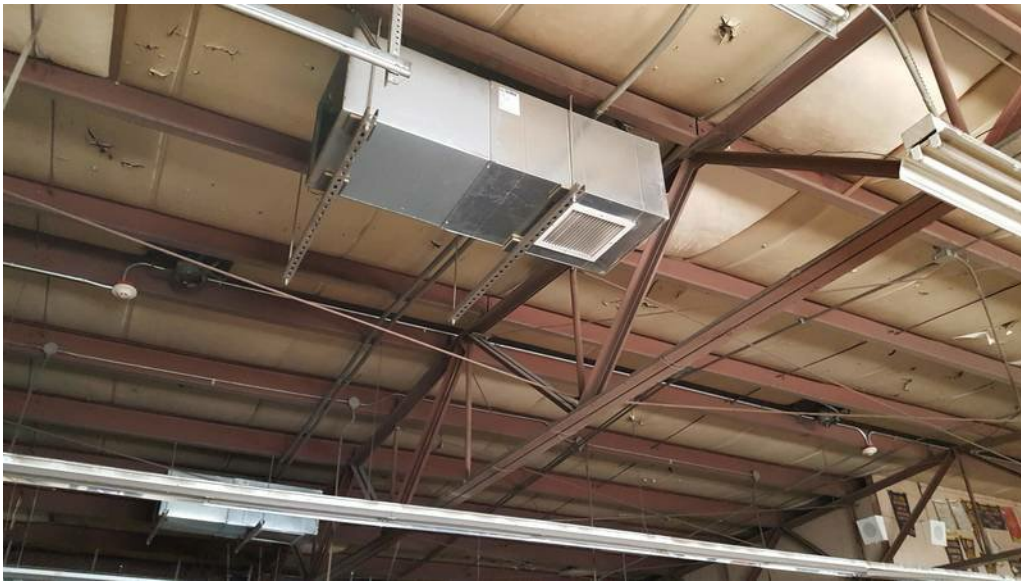
Figure 1-5. Overhead mechanical unit.

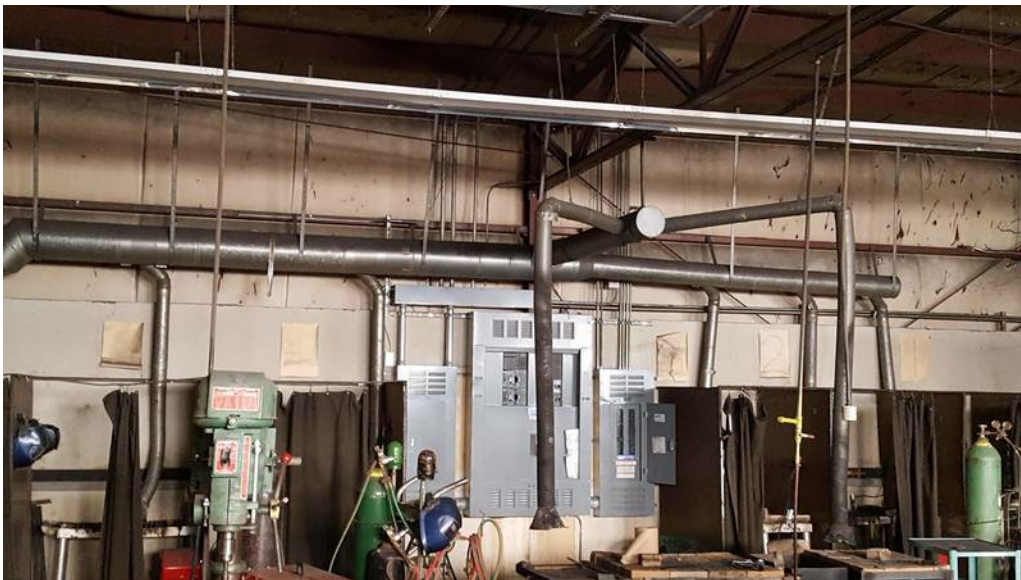
Figure 1-6. Ventilation and electrical panels near welding stalls.

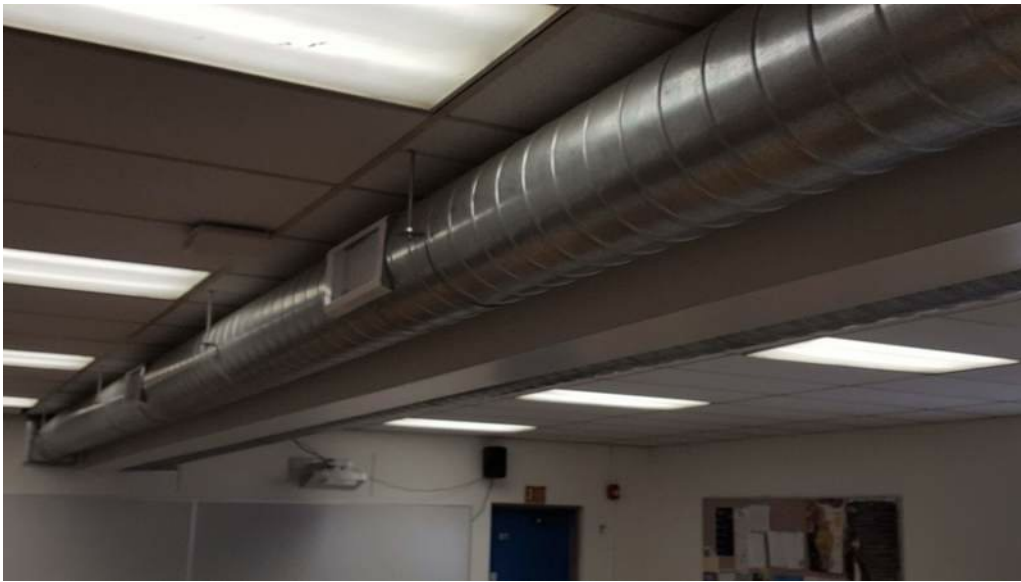
Figure 1-7. Classroom space with exposed ducting.

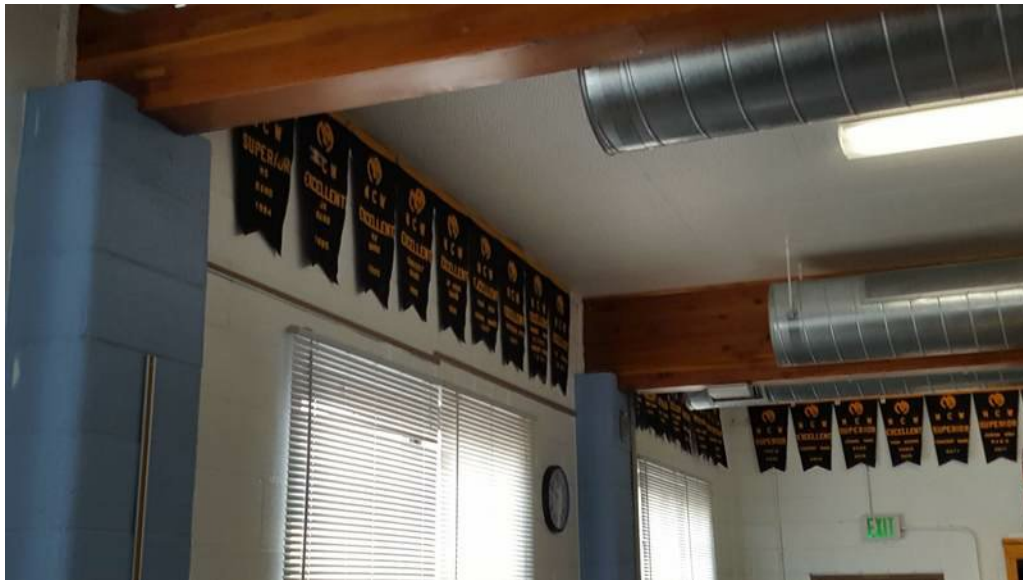
Figure 1-1. Glulam beams framing into CMU pilasters.

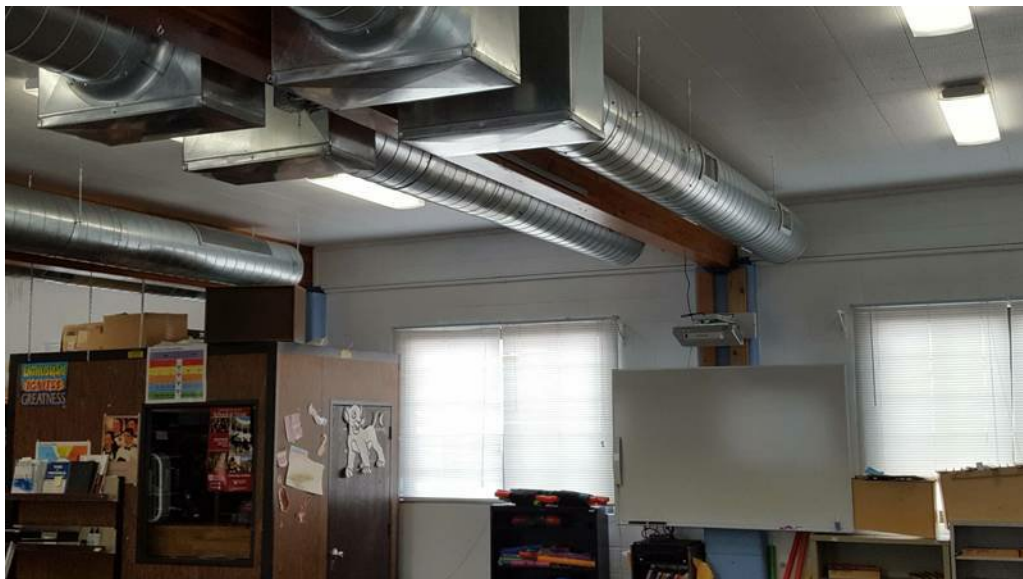
Figure 1-2. Exposed ductwork.

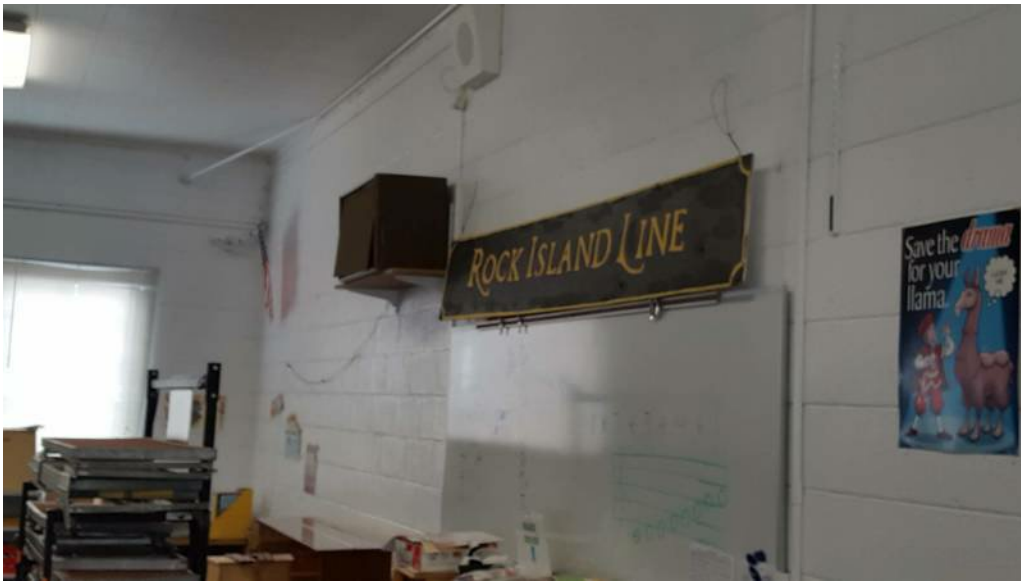
Figure 1-3. Small whiteboard attached to wall.

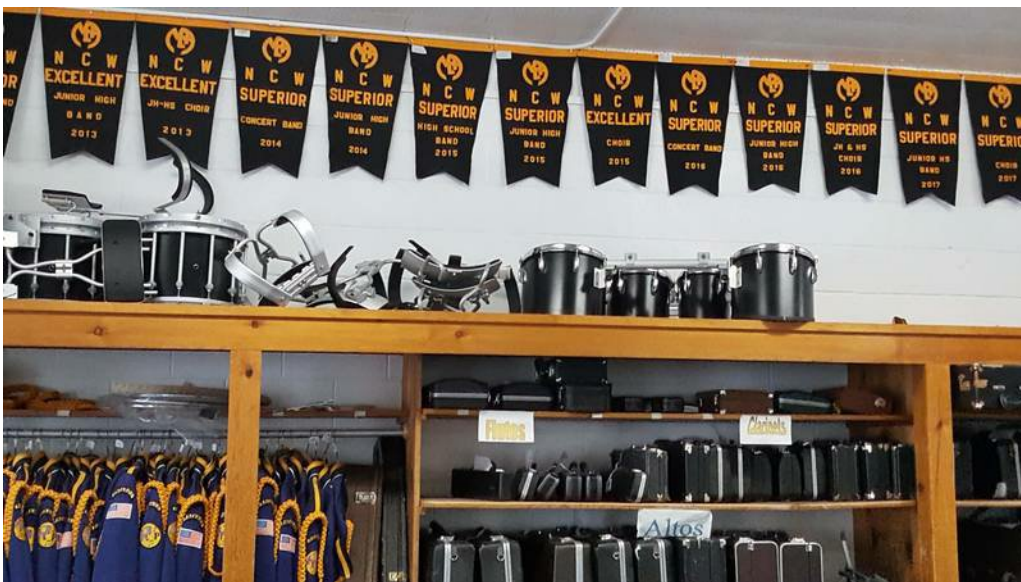
Figure 1-4. Instrument storage shelves.

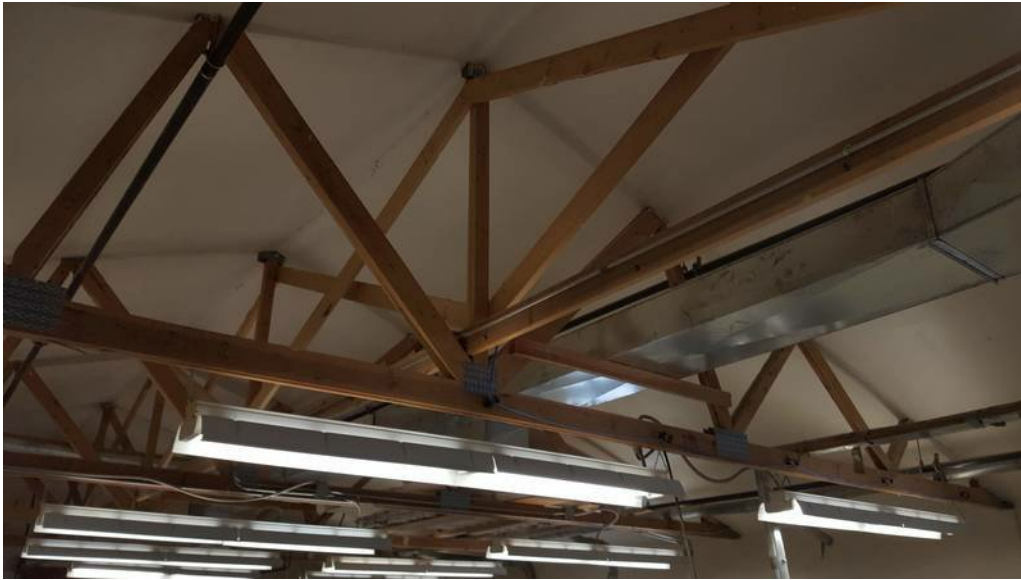
Figure 1-1. Prefabricated wood girders with truss infill.

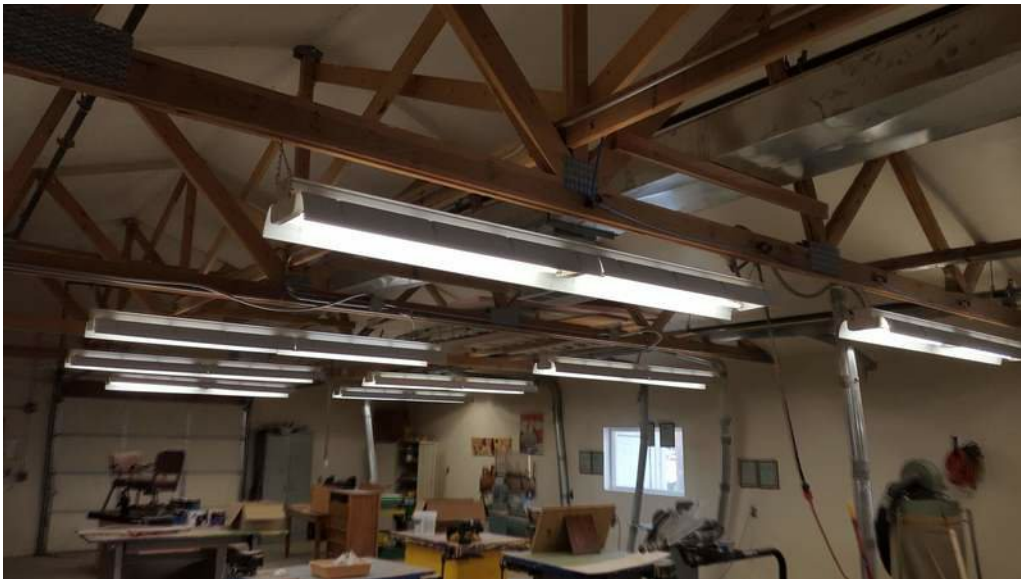
Figure 1-2. View looking southeast in shop, showing ductwork, electrical, and lighting.

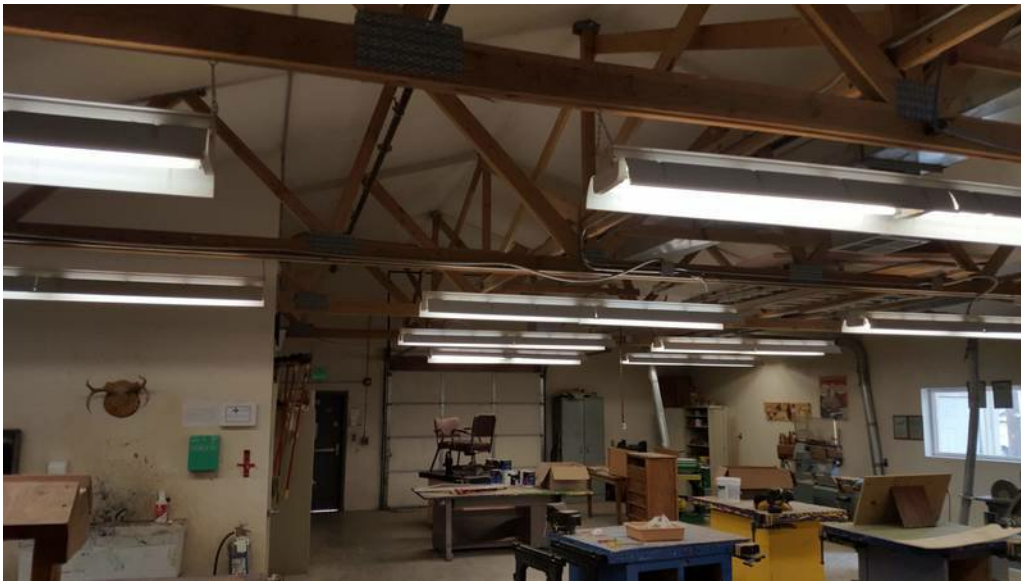
Figure 1-3. Additional view showing garage door on southeast end.

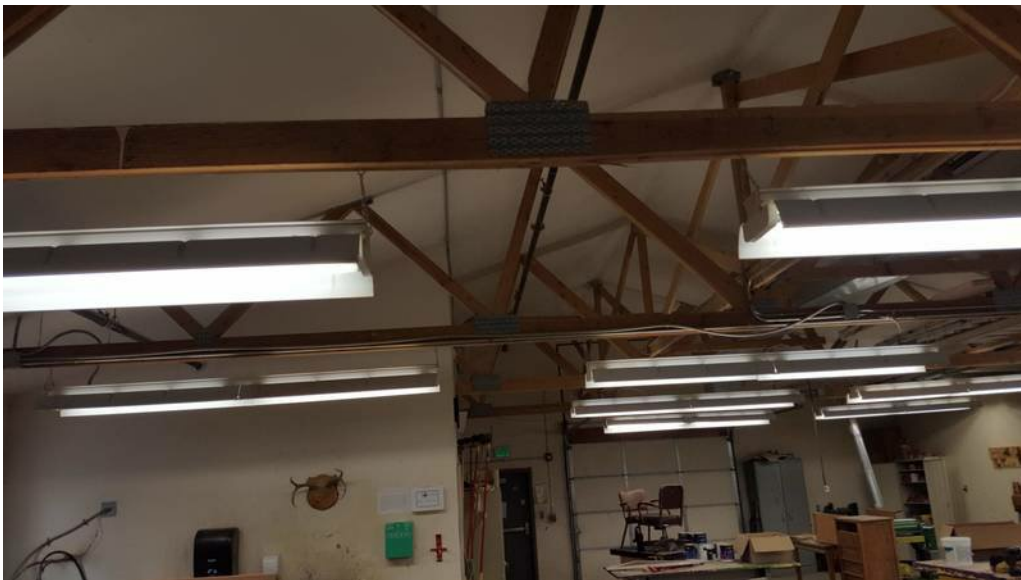
Figure 1-4. Fire suppression piping above truss bottom chords, with a wood-framed partition wall in background.

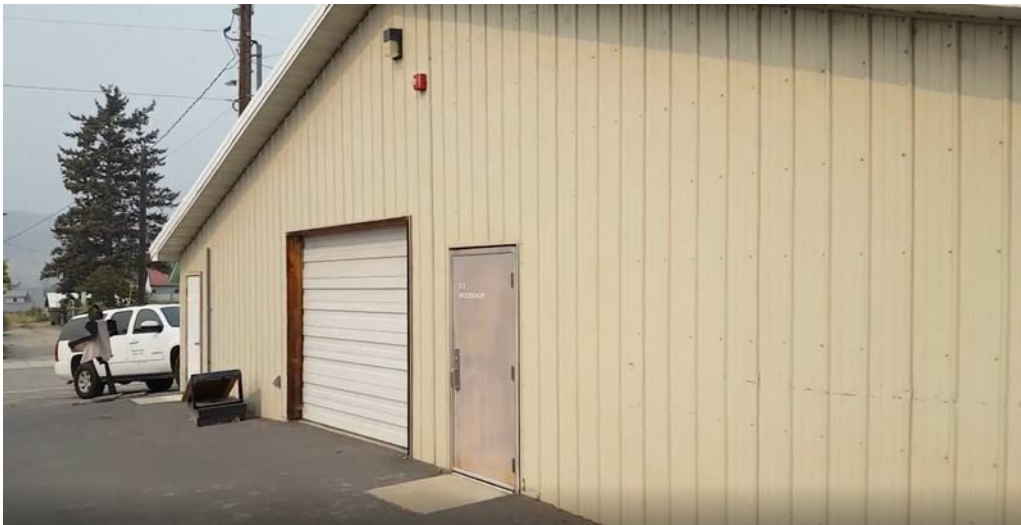
Figure 1-5. Southeast exterior wall.

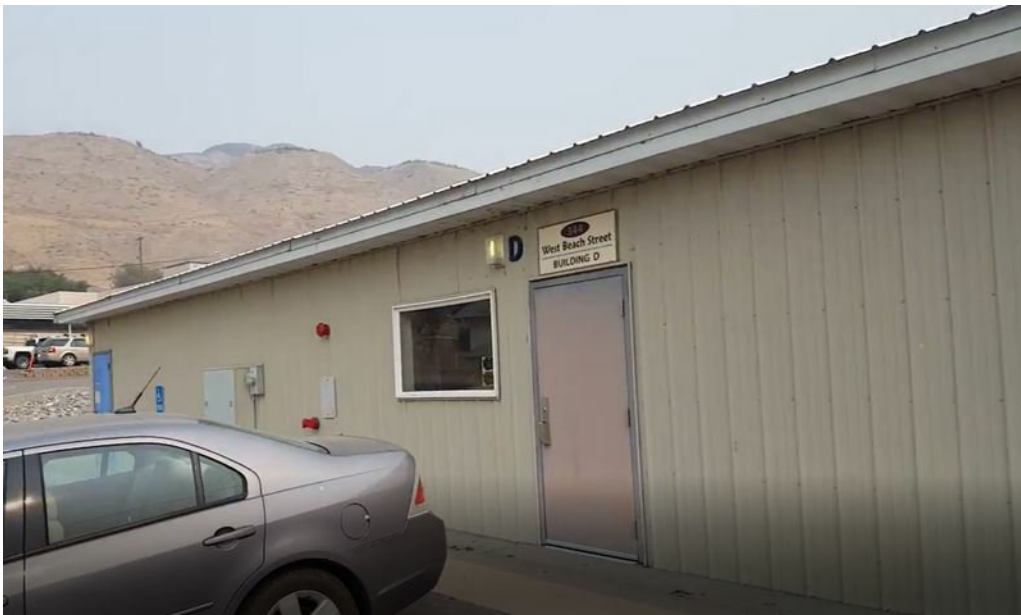
Figure 1-6. Southwest exterior wall.
